New York State Department of Transportation

PIA Safety Flag NB23CTW004

BIN: 1065318

Feature Carried: 278I278IX2M23027

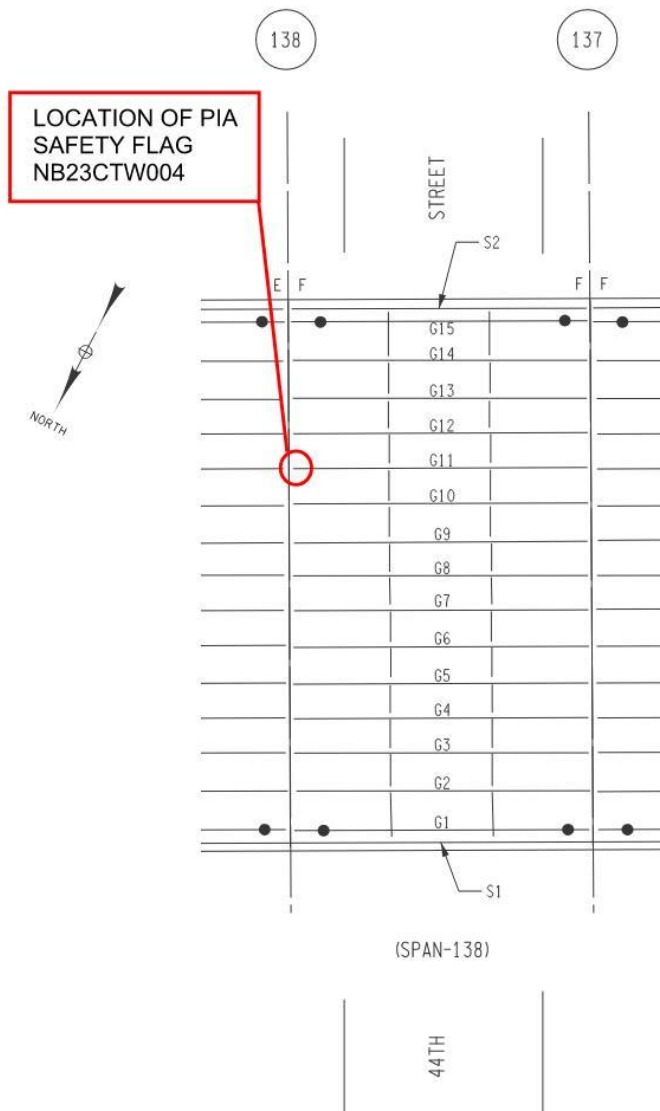
Photo Number: 1

The subject location is at 44th Street and 3rd Avenue eastbound.

**Attachment Description: Flag Location Plan.**

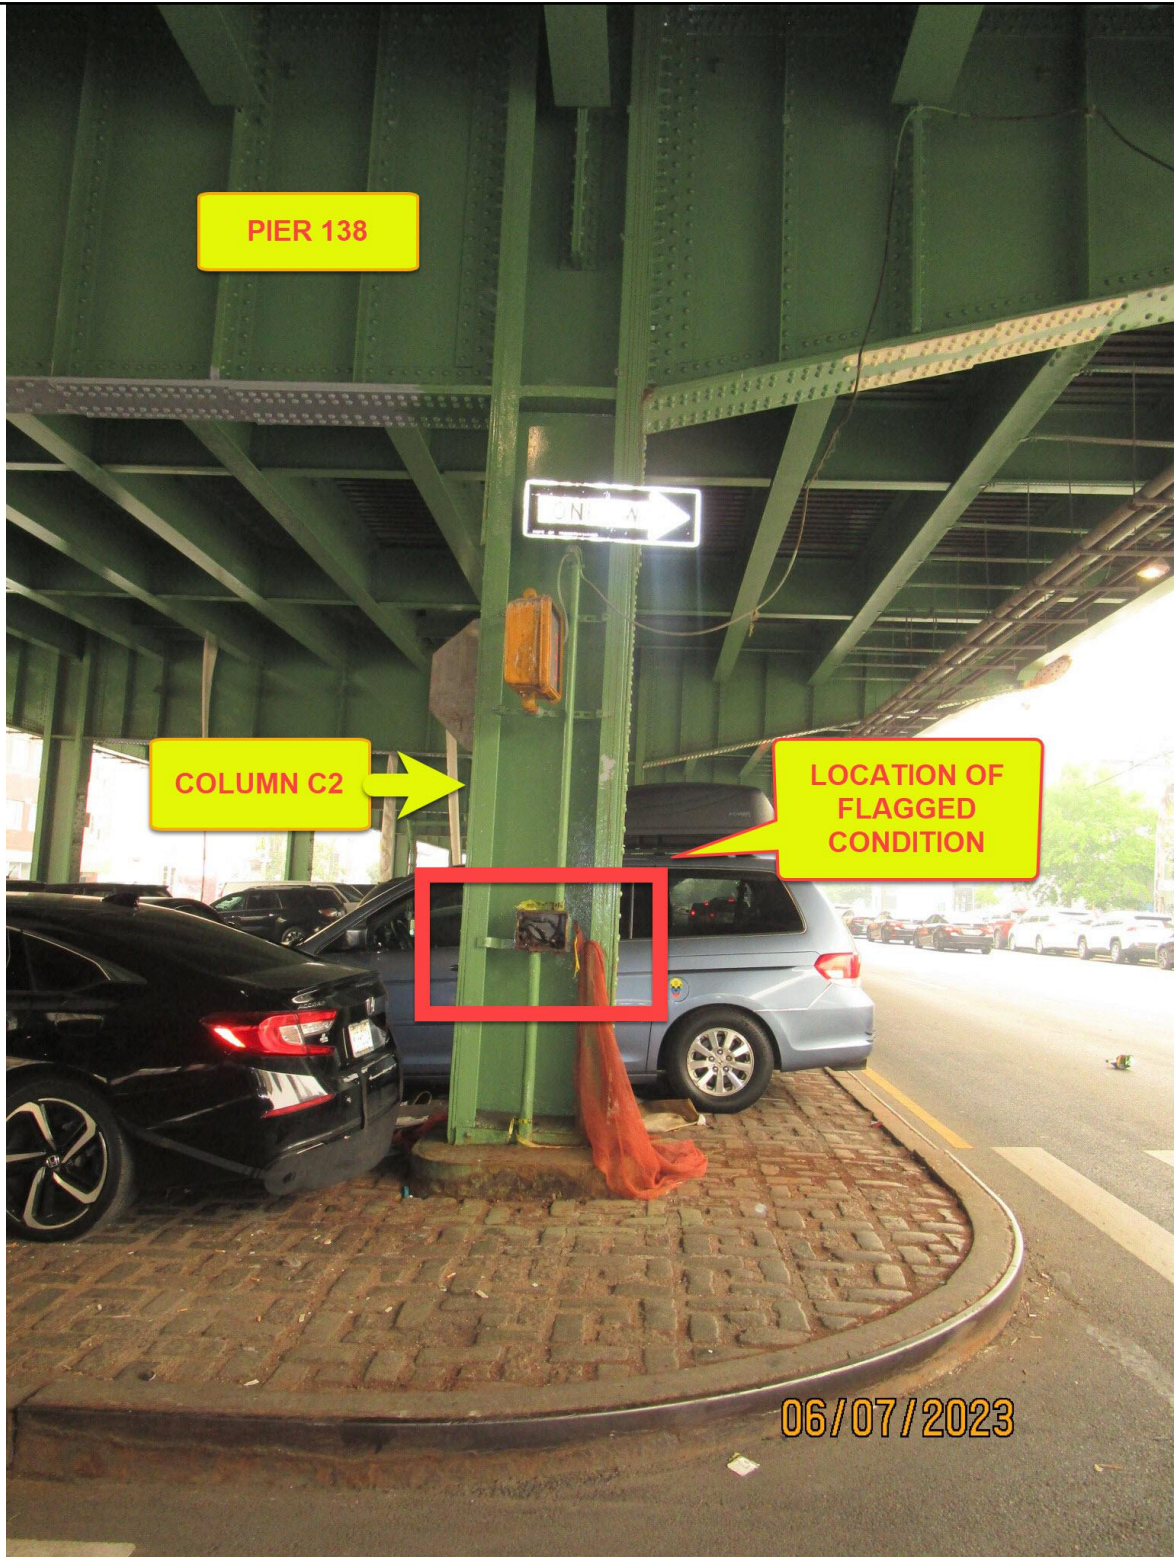
Photo Number: 2

Attachment Description: General view of the Flagged location. Looking End.

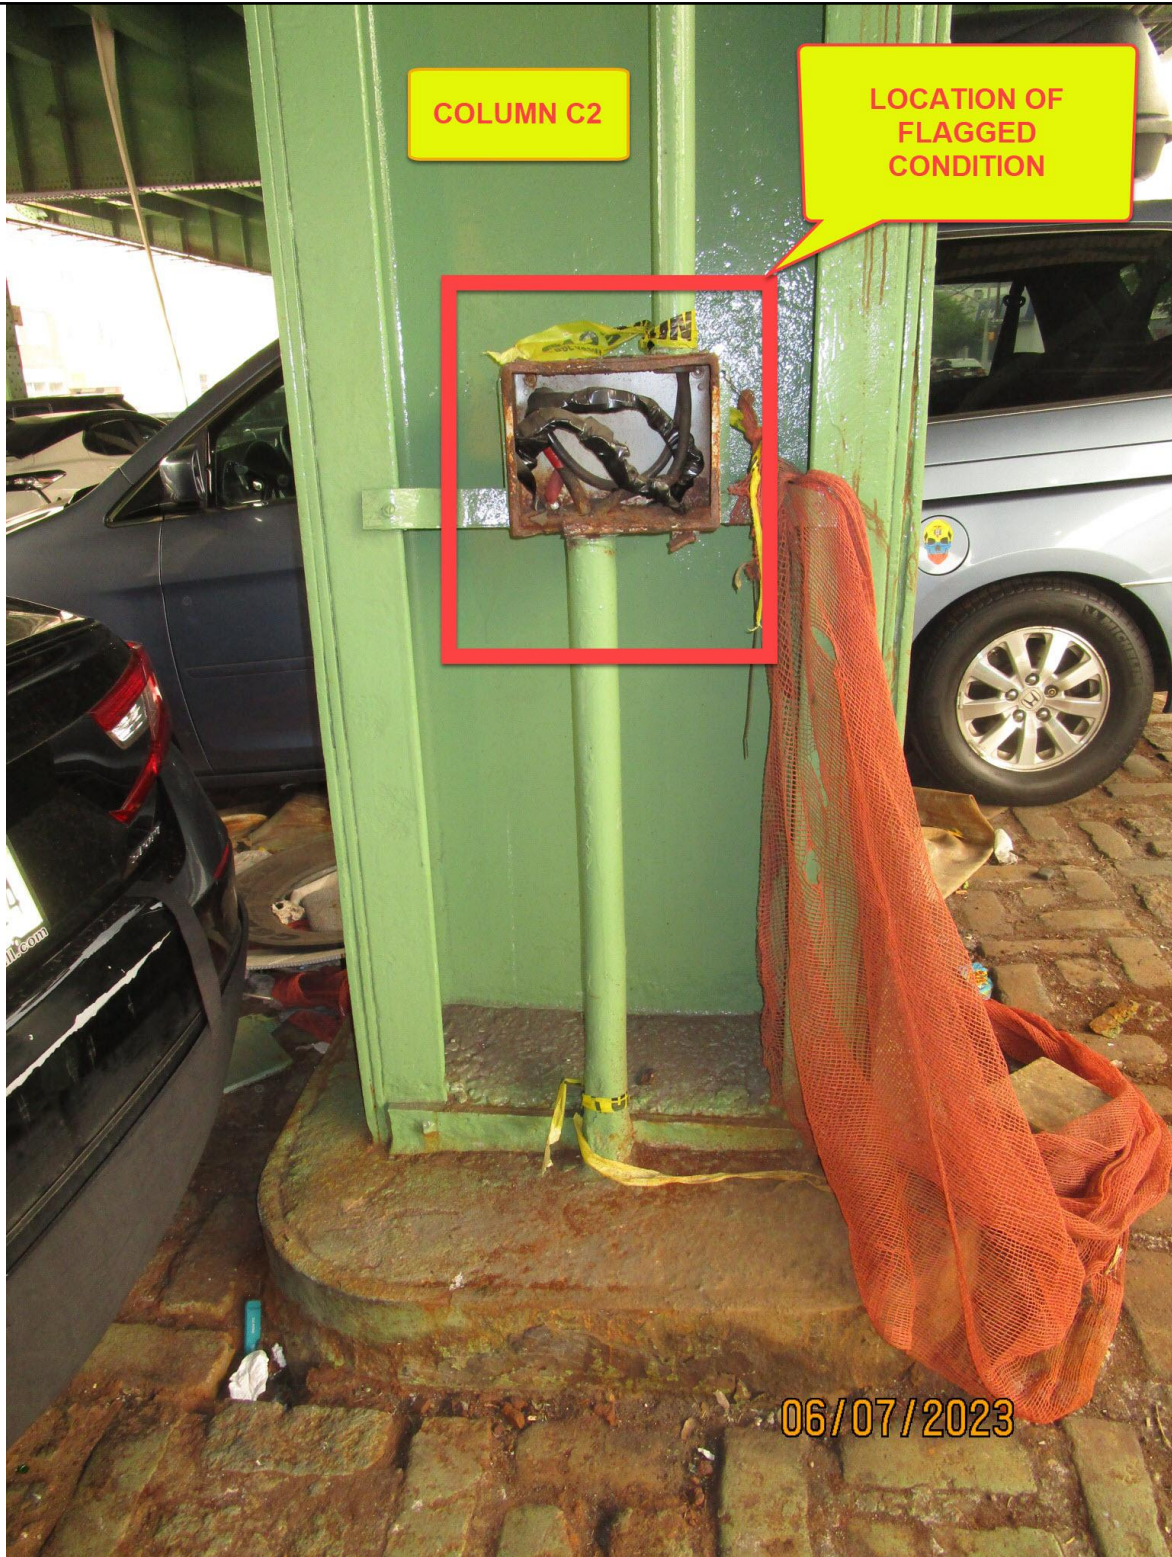
Photo Number: 3

This PIA Safety Flag No. NB23CTW004 is a New Flag.
Location: Span 138, Pier 138, Column C2 at the base.

Attachment Description: Location of Flagged condition at Pier 138, Column C2. Looking End.

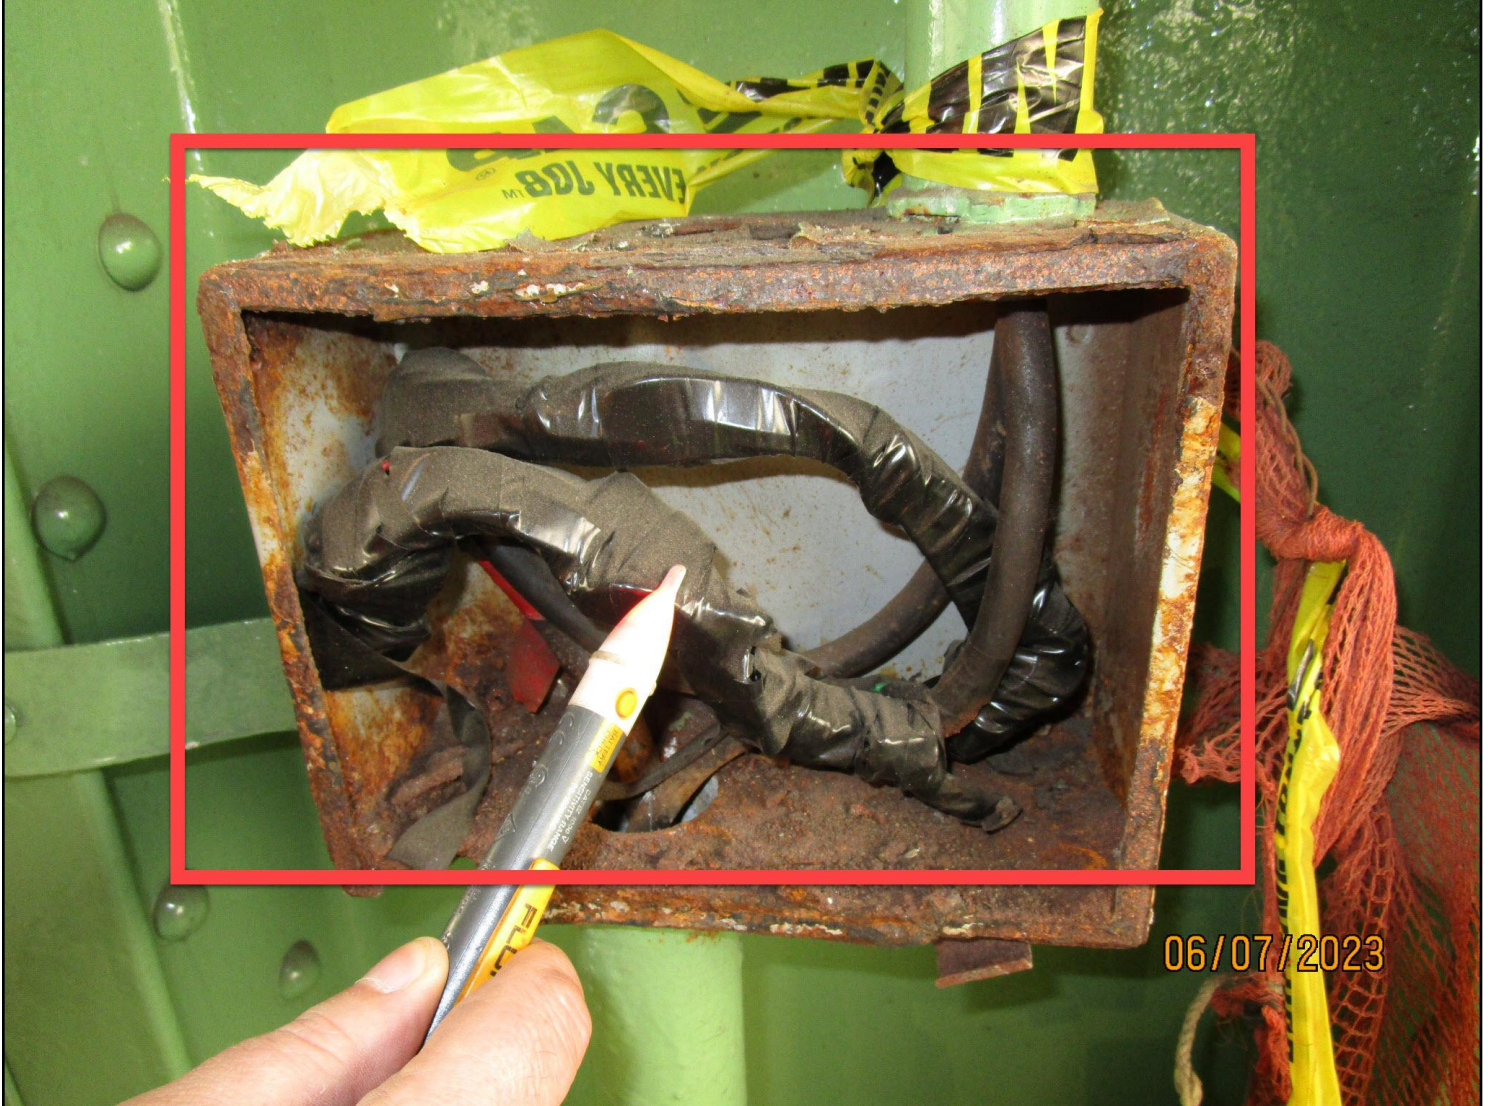
Photo Number: 4

At Span 138, Pier 138, Column C2 begin face, an electrical junction box attached to the face of the column is missing cover. There are exposed live wires at the junction box. The condition is at the base of the column, and is accessible by the public.

Attachment Description: Close-up view of the electrical junction box with exposed live wires. Looking End.
